Canton Tower Case Study

A successful implementation of a non-chemical solution for scale and rust removal and prevention in a water-cooled HVAC system
Author: Rex S. Chan, Director, KProject Solutions

Customer Case Study

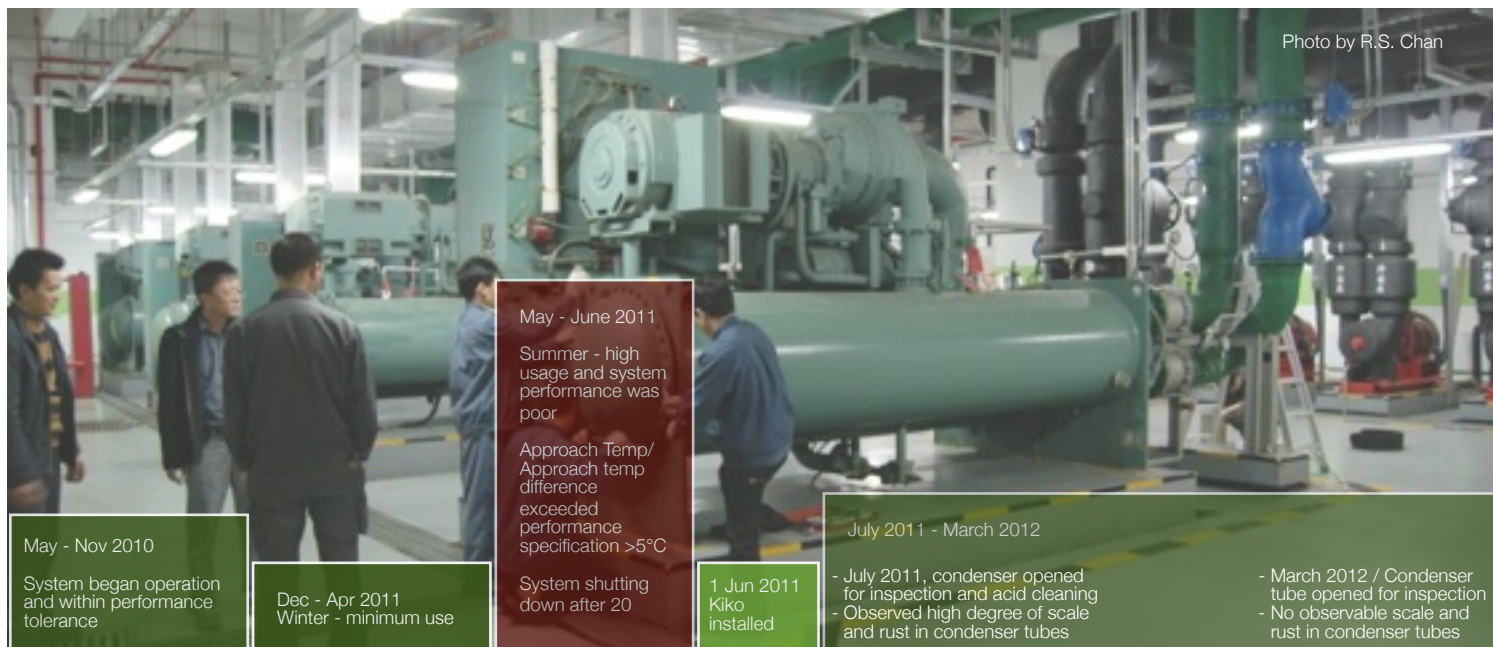
Scale & Rust Problem

System was very dirty with scale formation and rust and shutting down after 20 minutes of operation.
Approach Temp or Approach temperature difference was $> 5^{\circ}\text{C}$

Opening Condenser

for inspection on 2 March, 2012.

Clean Condenser Tubes

Free of scale and rust since installing Kiko cartridges in June 2011

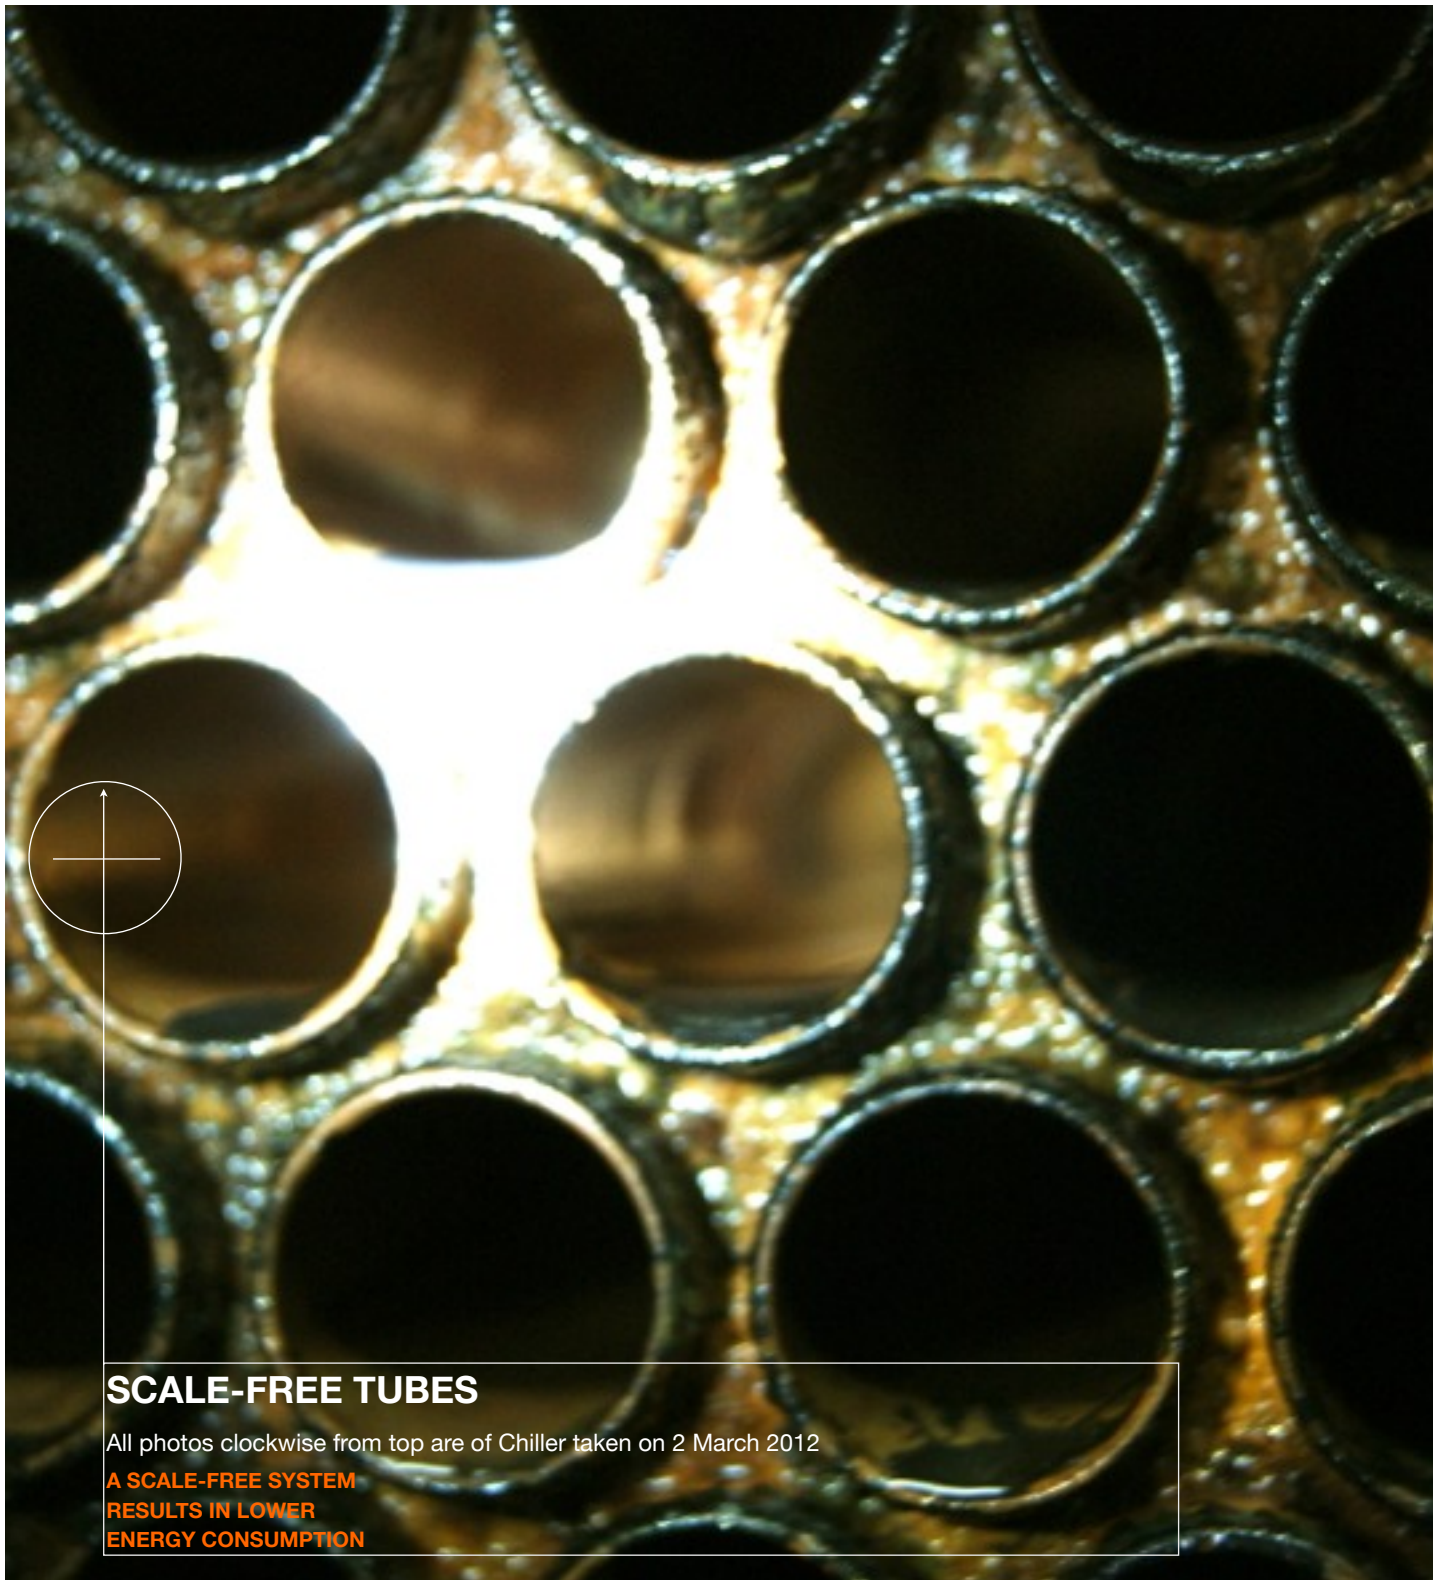
SCALE-FREE TUBES

This case study concluded with the opening of the condenser for inspection on 2nd March, 2012 and the confirmation that the condenser tubes was free of scale and rust formation. Since scale inhibiting chemicals was not used in the HVAC water system, the result of the clean condenser tubes is confirmed to be attributed to the installation of Kiko Water conditioning technology.

All photos clockwise from top are of Chiller taken on 2 March 2012

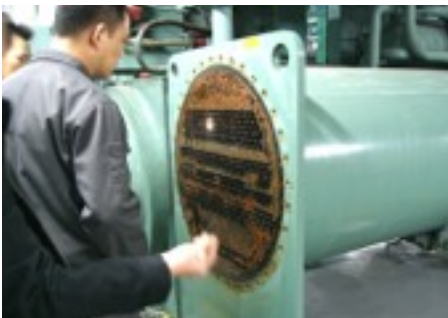
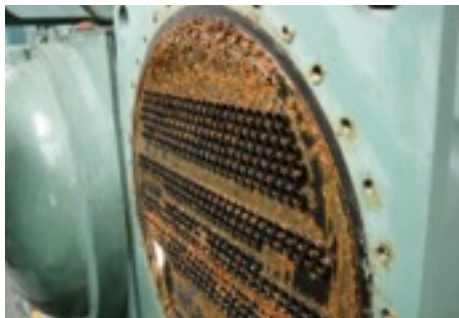
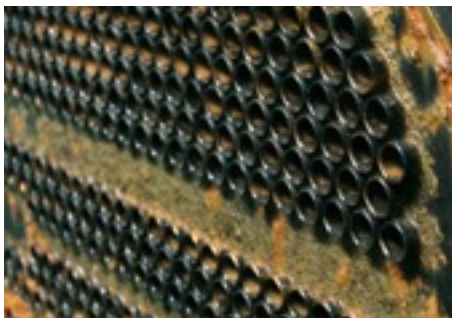
Upon opening Chiller #1, the tubes was found to be clean and scale-free, however, rust was noticed to have accumulated on the end plate of the condenser vessel. It is surmised that this accumulation is due to two factors:

- Slower water flow at end section of the condenser
- the lack of anti-rust coating on the plate
